USB-1608FS 1.87 Firmware Update
Measurement Computing Corporation

Firmware version 1.87

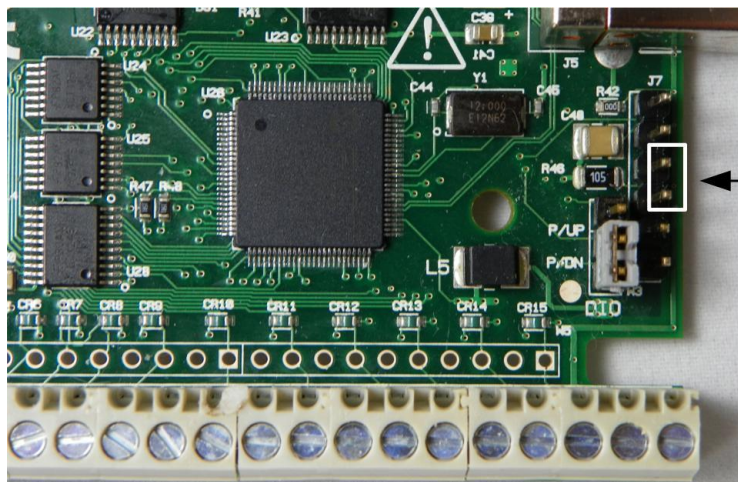
← Boot loader jumper

1. Download the 'USB-1608fs.hex' file and copy it to the FirmwareImages subdirectory of the DAQ installation directory ("Program Files\Measurement Computing\DAQ\FirmwareImages" by default).
2. Disconnect the USB-1608FS from your computer.
3. With a Phillips screw driver, loosen the 3 screws and remove the PCB from the case.
4. Noting the location of the pull up/down DIO jumper (for later replacement), remove the pull jumper and place it over the middle 2 pins of the 6-pin J7 header (refer to the image below).

5. Connect the USB-1608FS to your computer. Note that the LED continuously blinks.
6. Run InstaCal, and allow the USB-1608FS-BOOT-LOADER device to be added to the board list.
7. With the device highlighted, click the Download Firmware toolbar icon to open the Firmware Loader dialog.
8. Click the Load Firmware button to start installing the firmware.
9. Allow the process to finish. The device will re-enumerate in Windows. After the firmware is installed, the Status field displays "Firmware update completed".
10. Refresh InstaCal and verify that a regular USB-1608FS device is now added.
11. Disconnect the USB-1608FS from your computer.
12. Return the jumper to the original position, place the PCB in the case and secure with the screws.
